# Planemart

## Pre-flight Fuel Test Essential To Safe Aircraft Operation

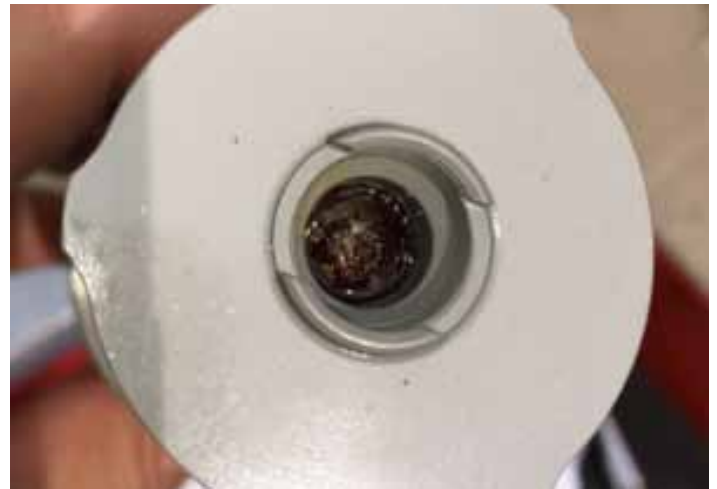
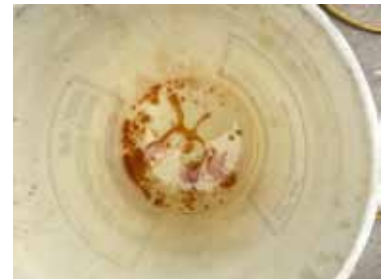
**A corroded check valve (ABOVE) can lead to contaminated fuel. (LEFT) Contaminated fuel is shown after being drained from an aircraft tank.**

Due to condensation, water may build up in the fuel system of the aircraft and on-site fuel storage containers. During the pre-flight check, it is a requirement to drain fuel from both the header tank and wing tank sumps to remove water from the fuel system.

"During recent on-site troubleshooting for an apparent fuel system issue, several pints of water were drained from the aircraft sumps. The operator was surprised by the amount of cruddy water that had accumulated in the system," said Lubos Hrdina, a GE Aviation field service engineer. "Stagnant water causes corrosion of fuel system components and reduced engine performance. In this specific case, the fuel control unit had to be replaced due to water contamination-caused corrosion."

Draining on-site fuel storage containers is recommended on a regular basis to remove accumulated water. A robust fuel storage system should have fuel-water separators and high quality (two microns) fuel filters to help reduce contamination.
